Oregon Scientific THWR800 water temperature sensor.

## Introduction

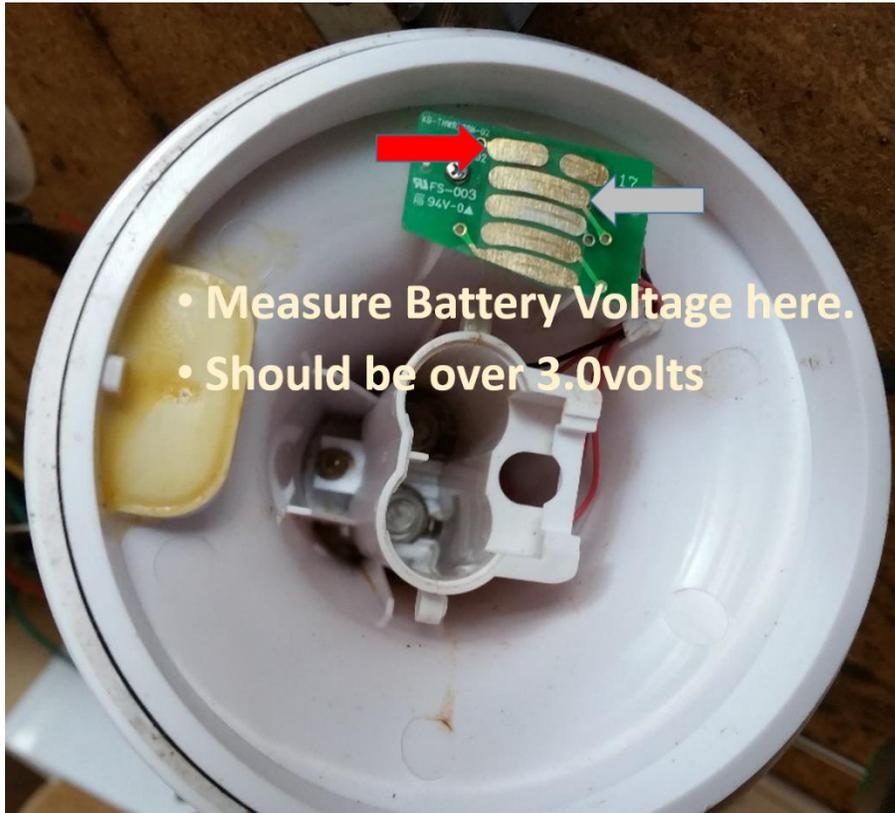
The most common problem the battery voltage not getting to the electronics. Check with the batteries installed.

If the battery voltage is low or non-existent; remove the battery holder with two screws.

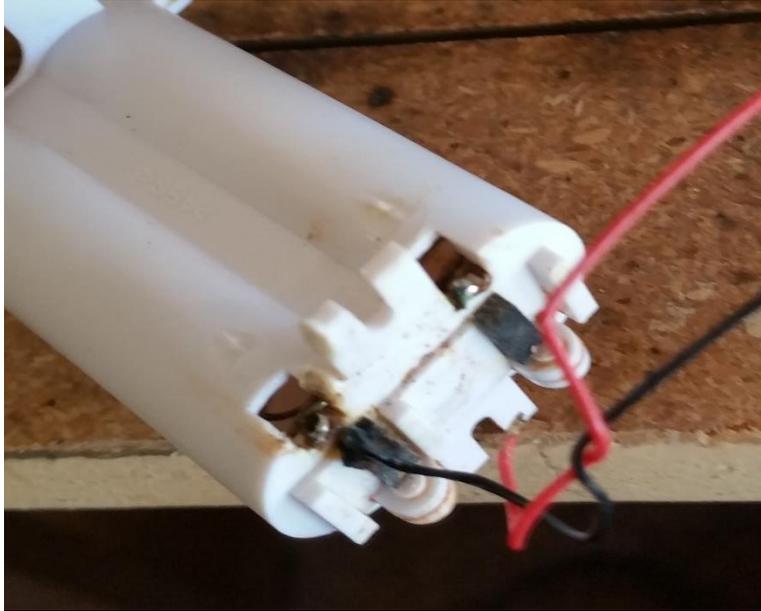
The most common problem I have found is broken or corroded leads to the battery holder.

So you can try to re-solder the leads but the wires used are so tiny it can be difficult. I replaced the leads with 22 awg stranded wire. Stranded is required because the pads on the circuit board are very small

and it is easy to pull them off the board. Stranded wire will help with the pulling. Try to clean the “Battery Springs” so they make good contact and clean the upper battery cover also.

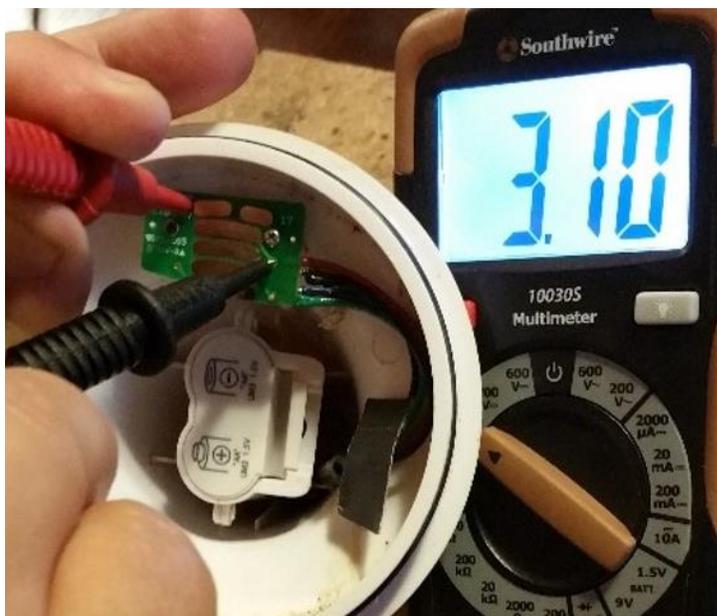
If you measure 3 volts you can try the sensor again. Notice I used the via holes to probe.

Try to glue or tape the wires back into place against the side to help with pulling.

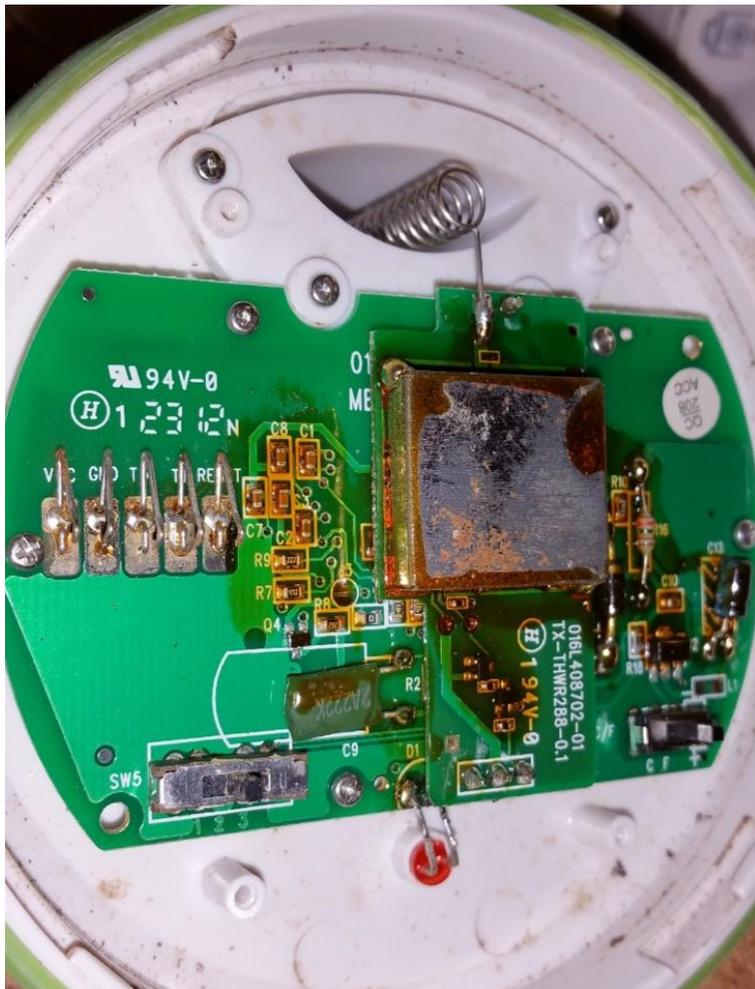
Corrosion is a reoccurring problem with the wiring inside the THWR800 temperature sensor. On the last repair I noticed some corrosion on the diode. Upon further inspection the diode lead was corroded through. I did not know how

significant that part was so I replaced the diode from a non-working temp sensor.

The diode is through hole mounted in the bottom board. So I used some solder wick to remove all the old solder and gently pull out the diode. This can be a little tricky because one of the through holes is under the upper board.

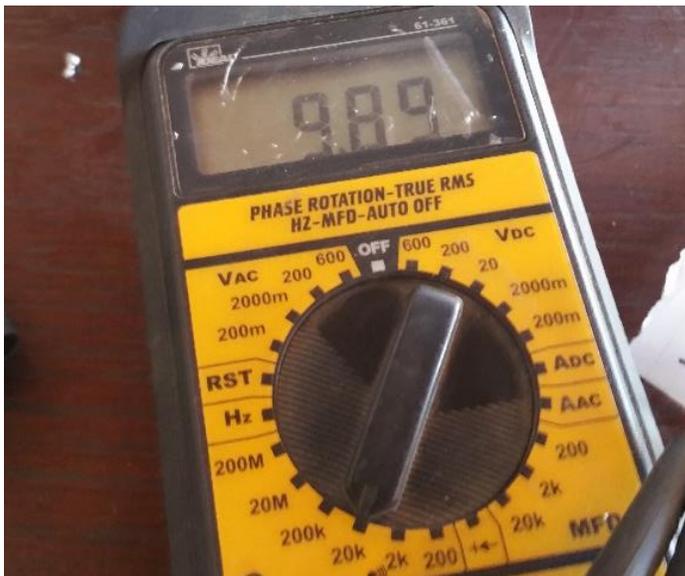
Because I keep fighting corrosion issues, I decided to make a change for the spa sensor. My intent was to extend the thermal sensor approximately 3ft. Place just the sensor in the spa water. The transmitter would be outside the spa in a dry location. Additionally I thought this might provide better RF connectivity.

I checked the Resistance

of the thermistor used to sense temperature.

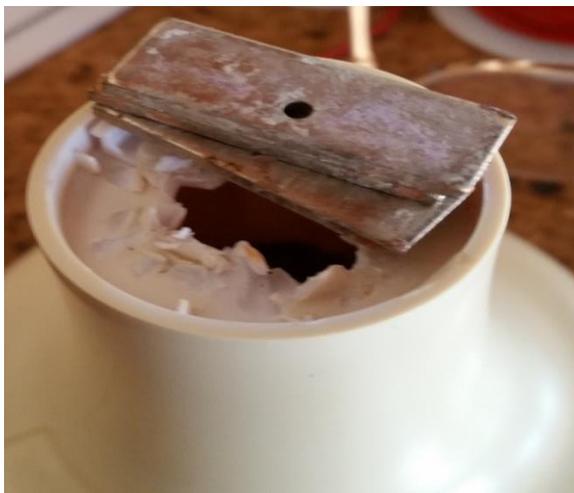
I found 3/8 inch heatshrink tubing. The sensor is glued into the base of the unit. I pried

the sensor out of the base of the unit and sanded it down round and smooth. I really broke off the base of the unit with

the sensor glued inside. There are 3 steel blocks in the base for ballast which I removed. I extended the leads with 22 awg stranded wire and fished it through the heatshrink tube.

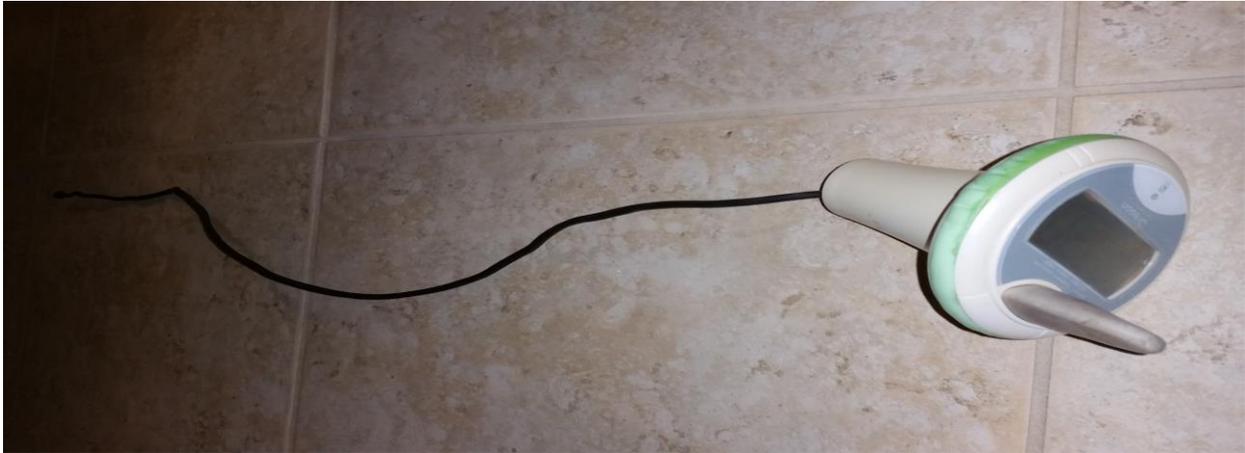
The final unit looks like this. I sealed up the bottom with waterproof caulking. I know it does not have the same functionality of the original unit. I am tired of performing significant repairs on these units every 3 months. Hopefully this will halt the corrosion.
